DOT/FAA/AR-96/21

Composite Failure Analysis Handbook Update 1

August 1997

Final Report

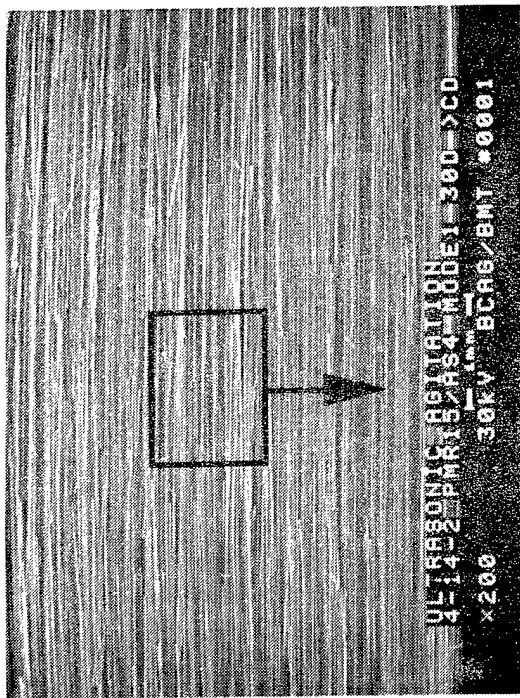
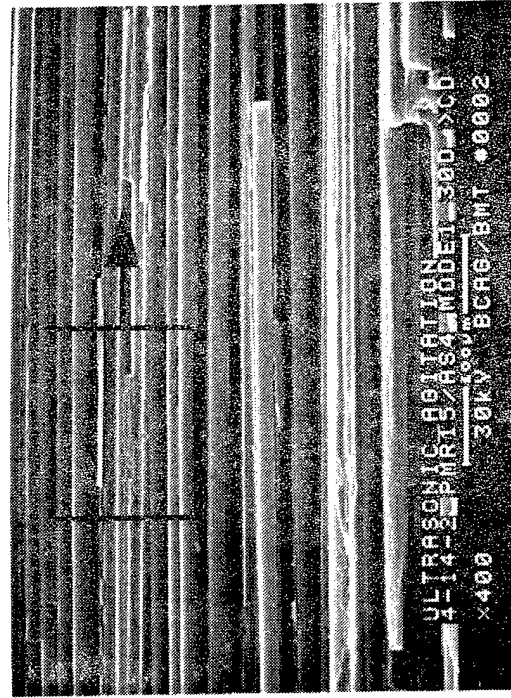
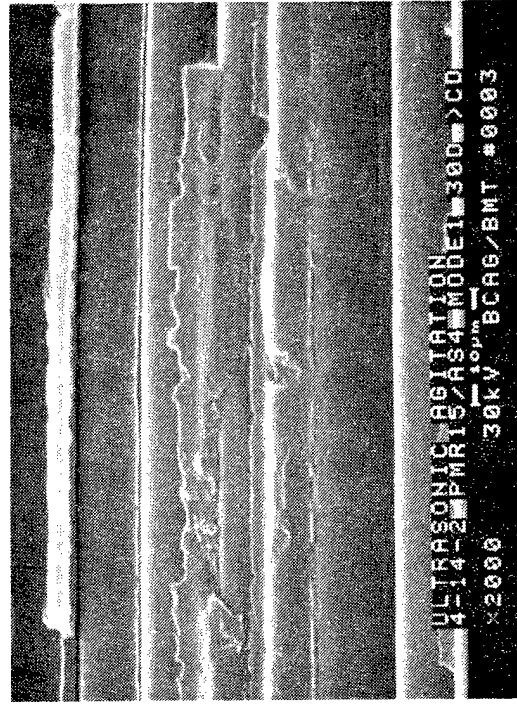
The effects of the exposure did not affect the fracture morphology to any noticeable degree. All of the characteristic mode I surface features were easily identified (Figure 3.3-9 through 3.3-15).

Figure 3.3-10. SEM Fractographs of a PMR-15/AS4 Interlaminar Mode I Tension Fracture Surface Exposed to Ultrasonic Agitation in Distilled Water for 24 hours

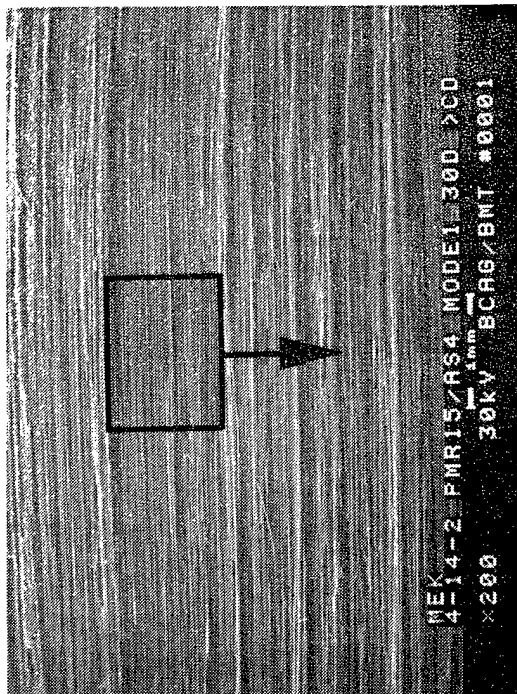
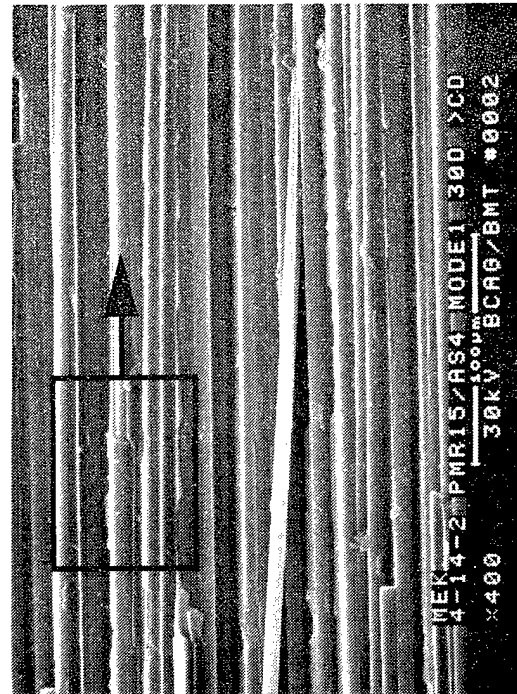
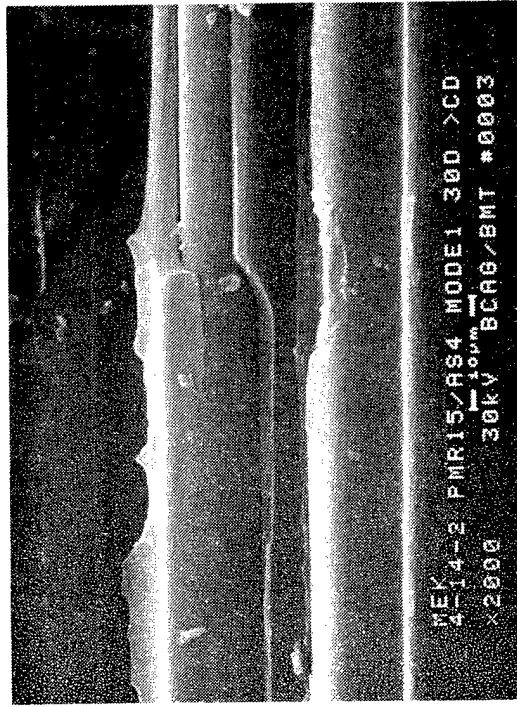
Figure 3.3-11. SEM Fractographs of a PMR-15/AS4 Interlaminar Mode I Tension Fracture Surface Exposed to MEK for 24 hours

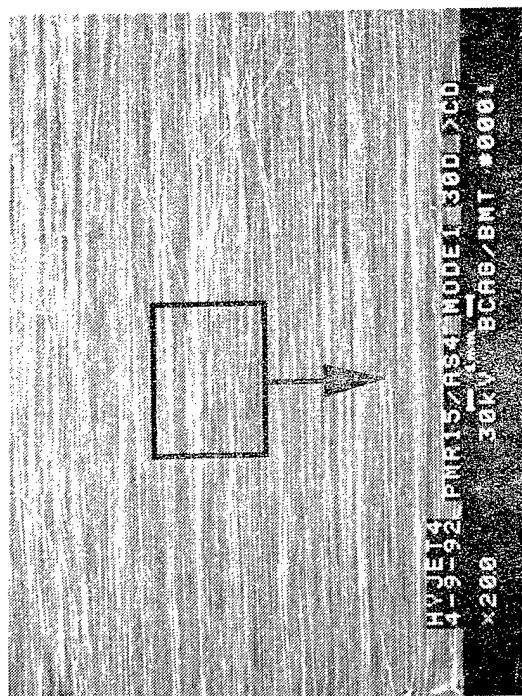
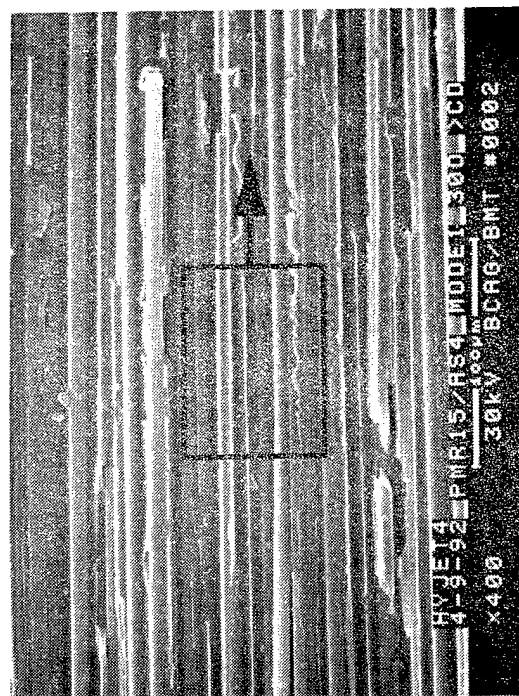
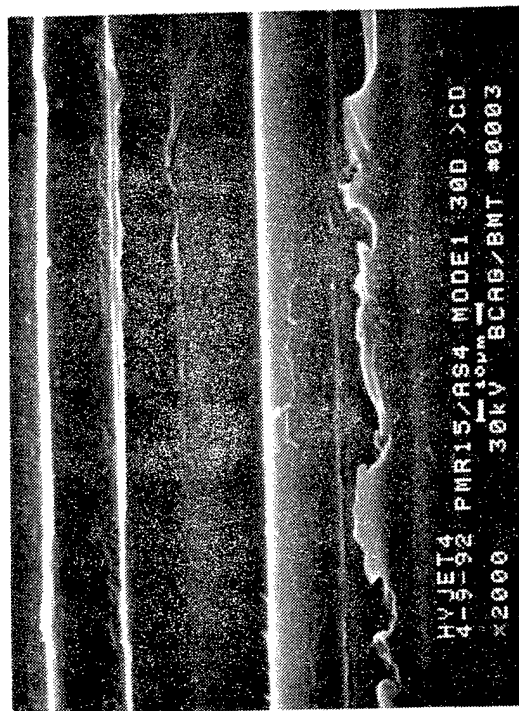
Figure 3.3-12. SEM Fractographs of a PMR-15/AS4 Interlaminar Mode I Tension Fracture Surface Exposed to Hydraulic Fluid for 7 Days

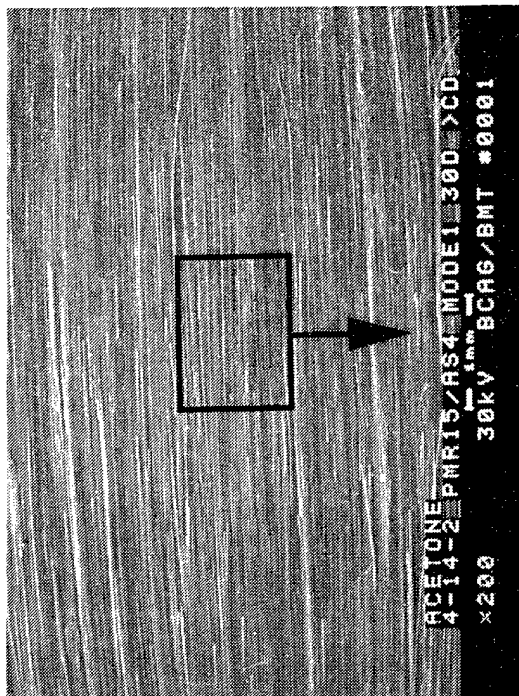
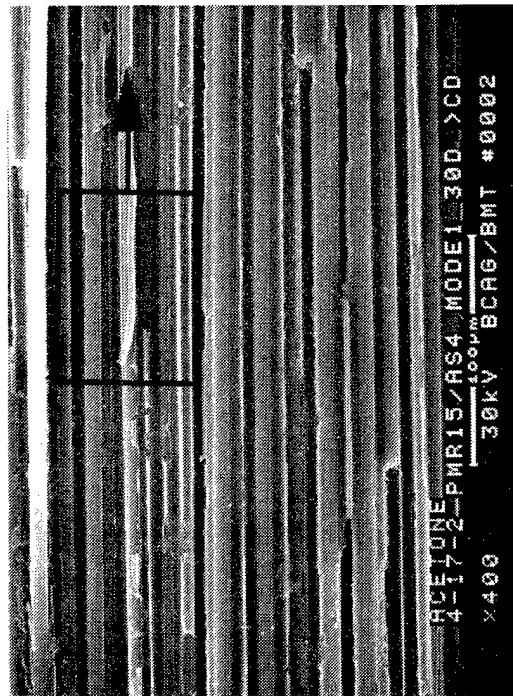
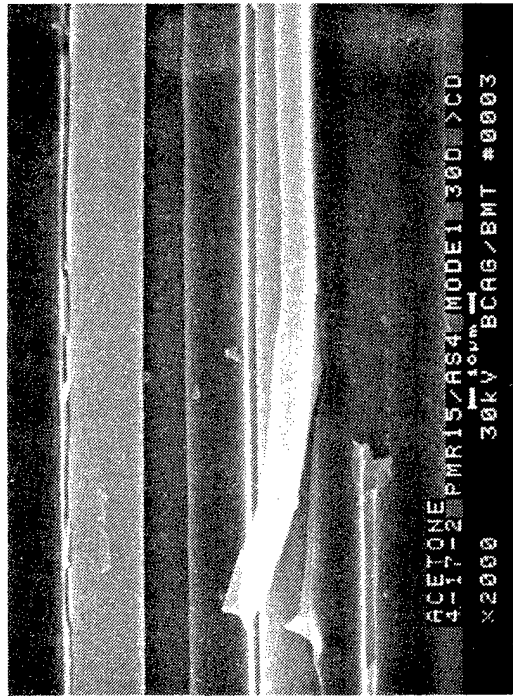
Figure 3.3-13. SEM Fractographs of a PMR-15/AS4 Interlaminar Mode I Tension Fracture Surface Exposed to Acetone for 24 hours

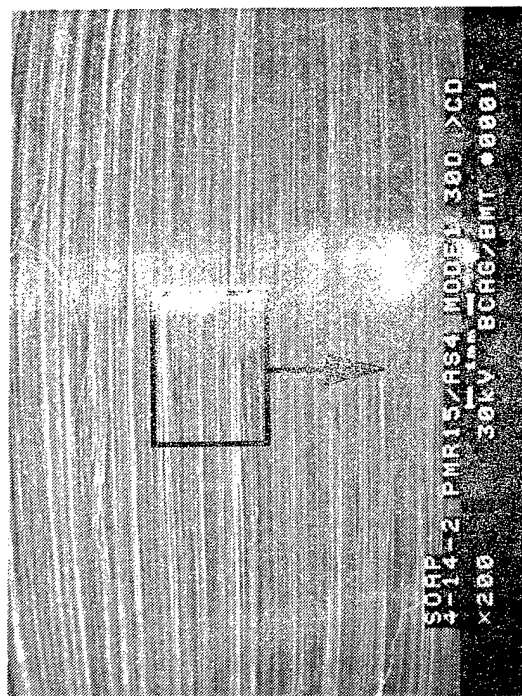
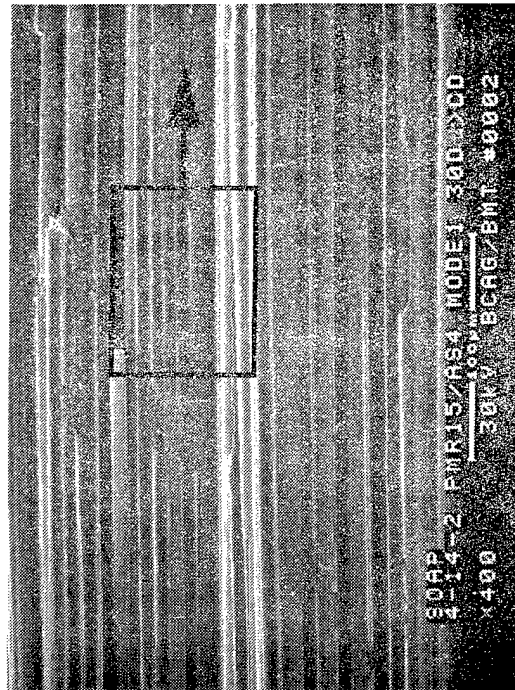
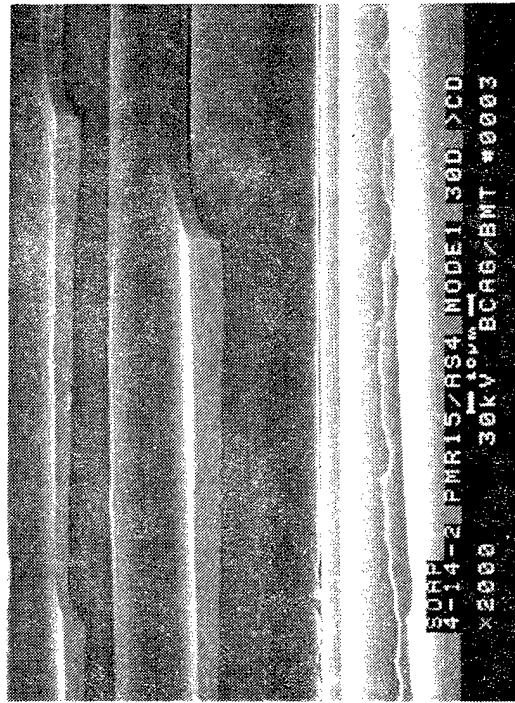
Figure 3.3-14. SEM Fractographs of a PMR-15/AS4 Interlaminar Mode I Tension Fracture Surface Exposed to Soap Solution for 24 hours

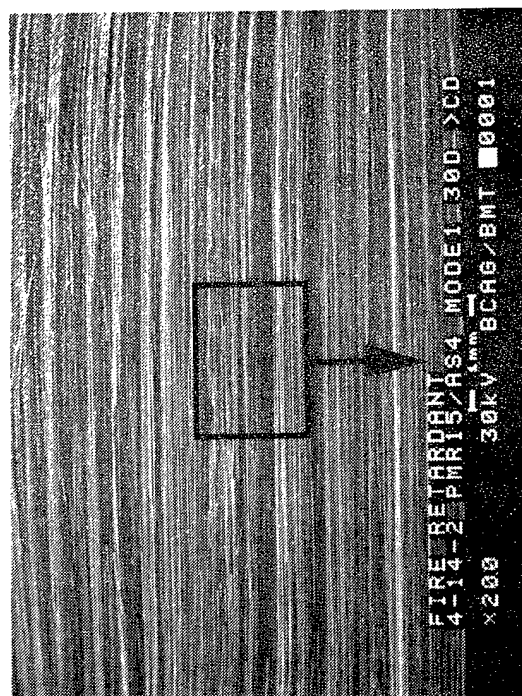
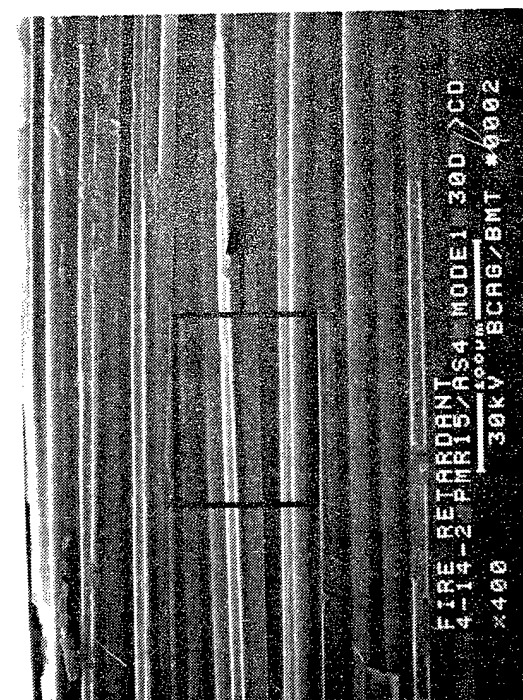
Figure 3.3-15. SEM Fractographs of a PMR-15/AS4 Interlaminar Mode I Tension Fracture Surface Exposed to Fire Retardant Foam for 7 Days

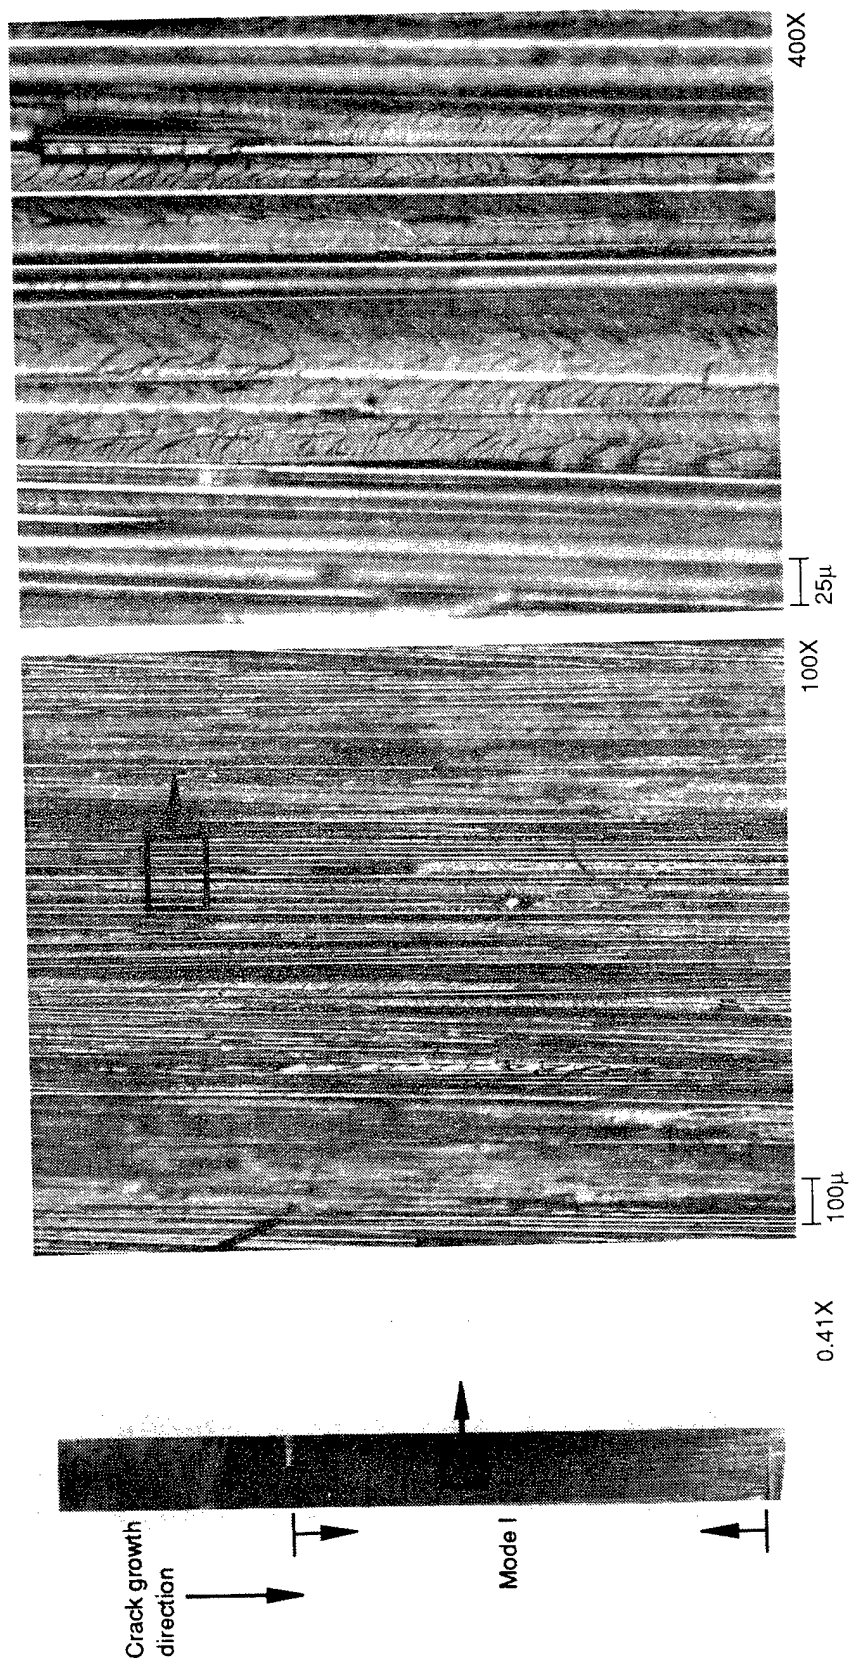
Figure 3.5-1. Optical Fractographs of BM/AS4 Interlaminar Mode I Tension Specimen Tested at RT/Dry

Visual observation revealed a smooth, glassy surface typical of an interlaminar mode I tension fracture. However, fragments of loose fibers were apparent on the fracture surface. These fibers were separated from the matrix (possibly due to weak fiber/matrix adhesion). Under the optical microscope, fine rivermarks were observed, indicating the overall crack propagation direction (Figure 3.5-1). As shown in Figure 3.5-2, SEM examination revealed rivermarks between the carbon fibers. These rivermarks indicated the crack growth is consistent with the mechanically induced crack direction.

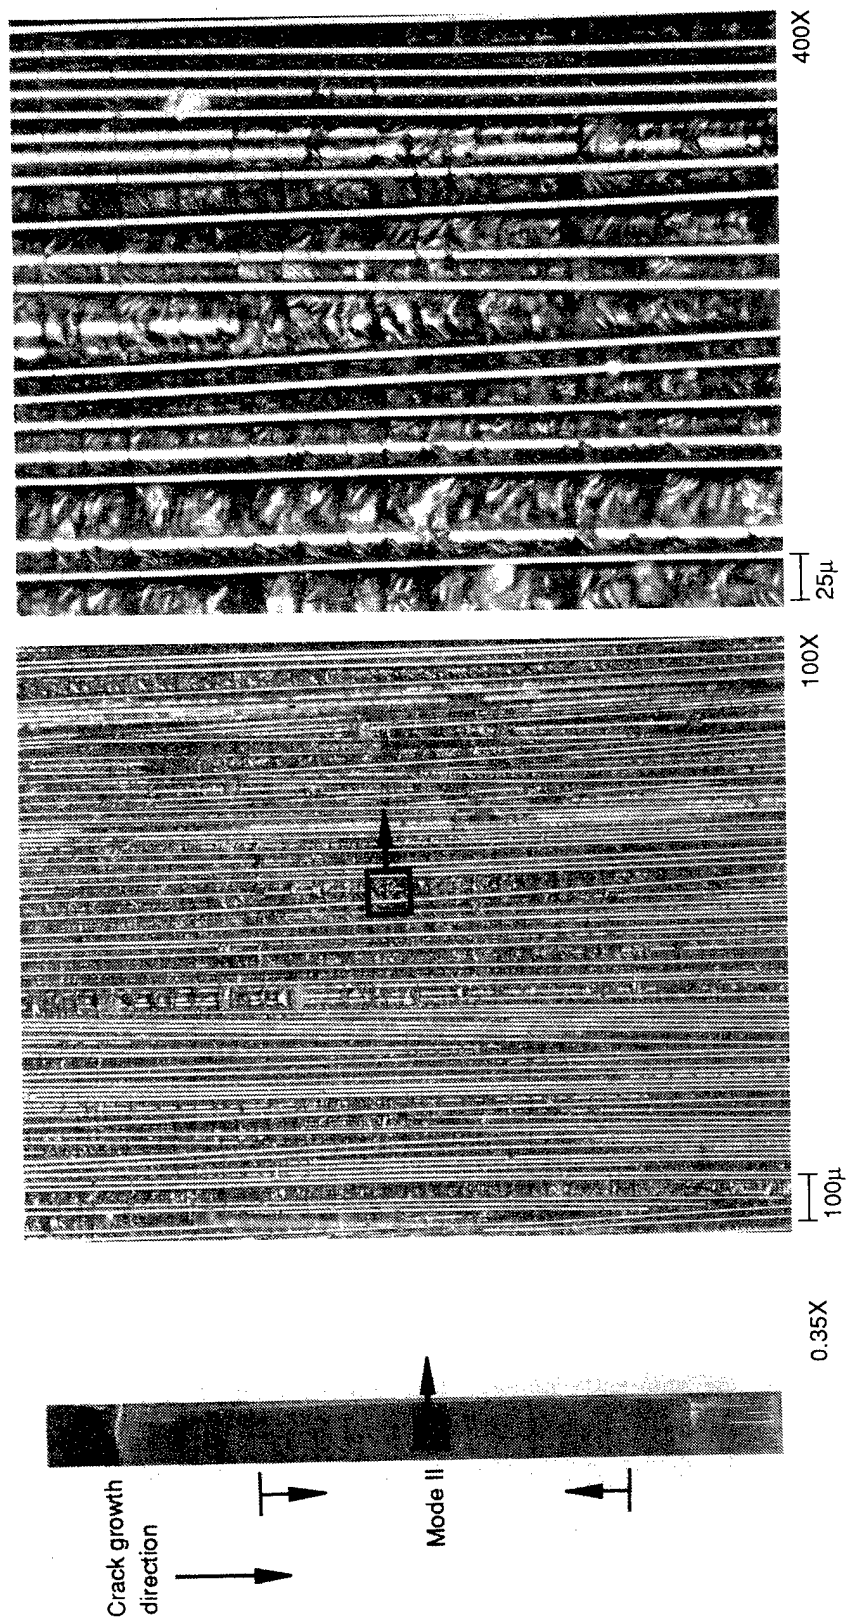
Figure 3.5-3. Optical Fractographs of BMI/AS4 Interlaminar Mode II Shear Specimen Tested at RT/Dry

Visual observation of the fracture surface revealed a flat but milky appearance when held at an angle to the light. The milky appearance is due to the hackle formation created by shear loading, which was observed at higher magnification under the optical microscope (Figure 3.5-3). SEM examination revealed hackles of different sizes, shapes, and tilt angles located between the carbon fibers (Figure 3.5-4).

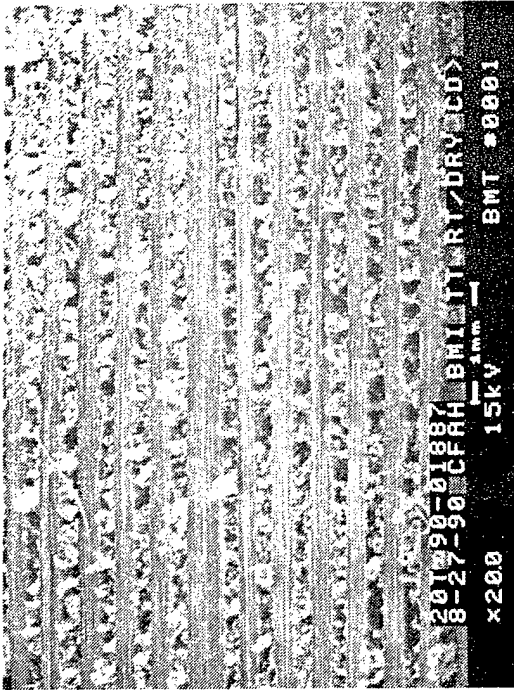
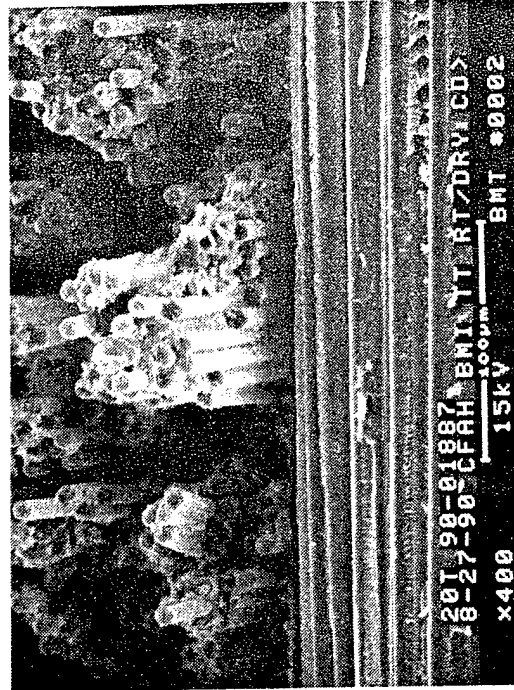
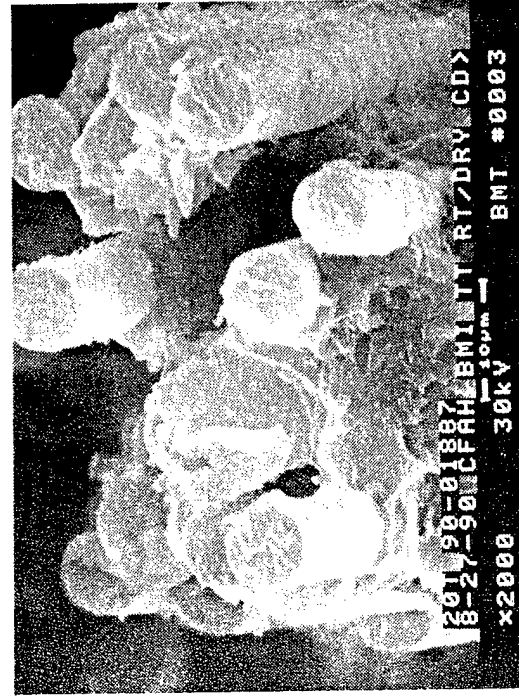
Figure 3.5-5. SEM Fractographs of an AS4/BMI Translaminar Tension RT/Dry Fracture

SEM fractography (Figure 3.5-5) revealed radial patterns on the fiber ends, indicating a resultant crack direction consistent with the mechanically induced direction. The specimen tested at 450° F did not fracture but only bent during the testing (Figure 3.5-6)

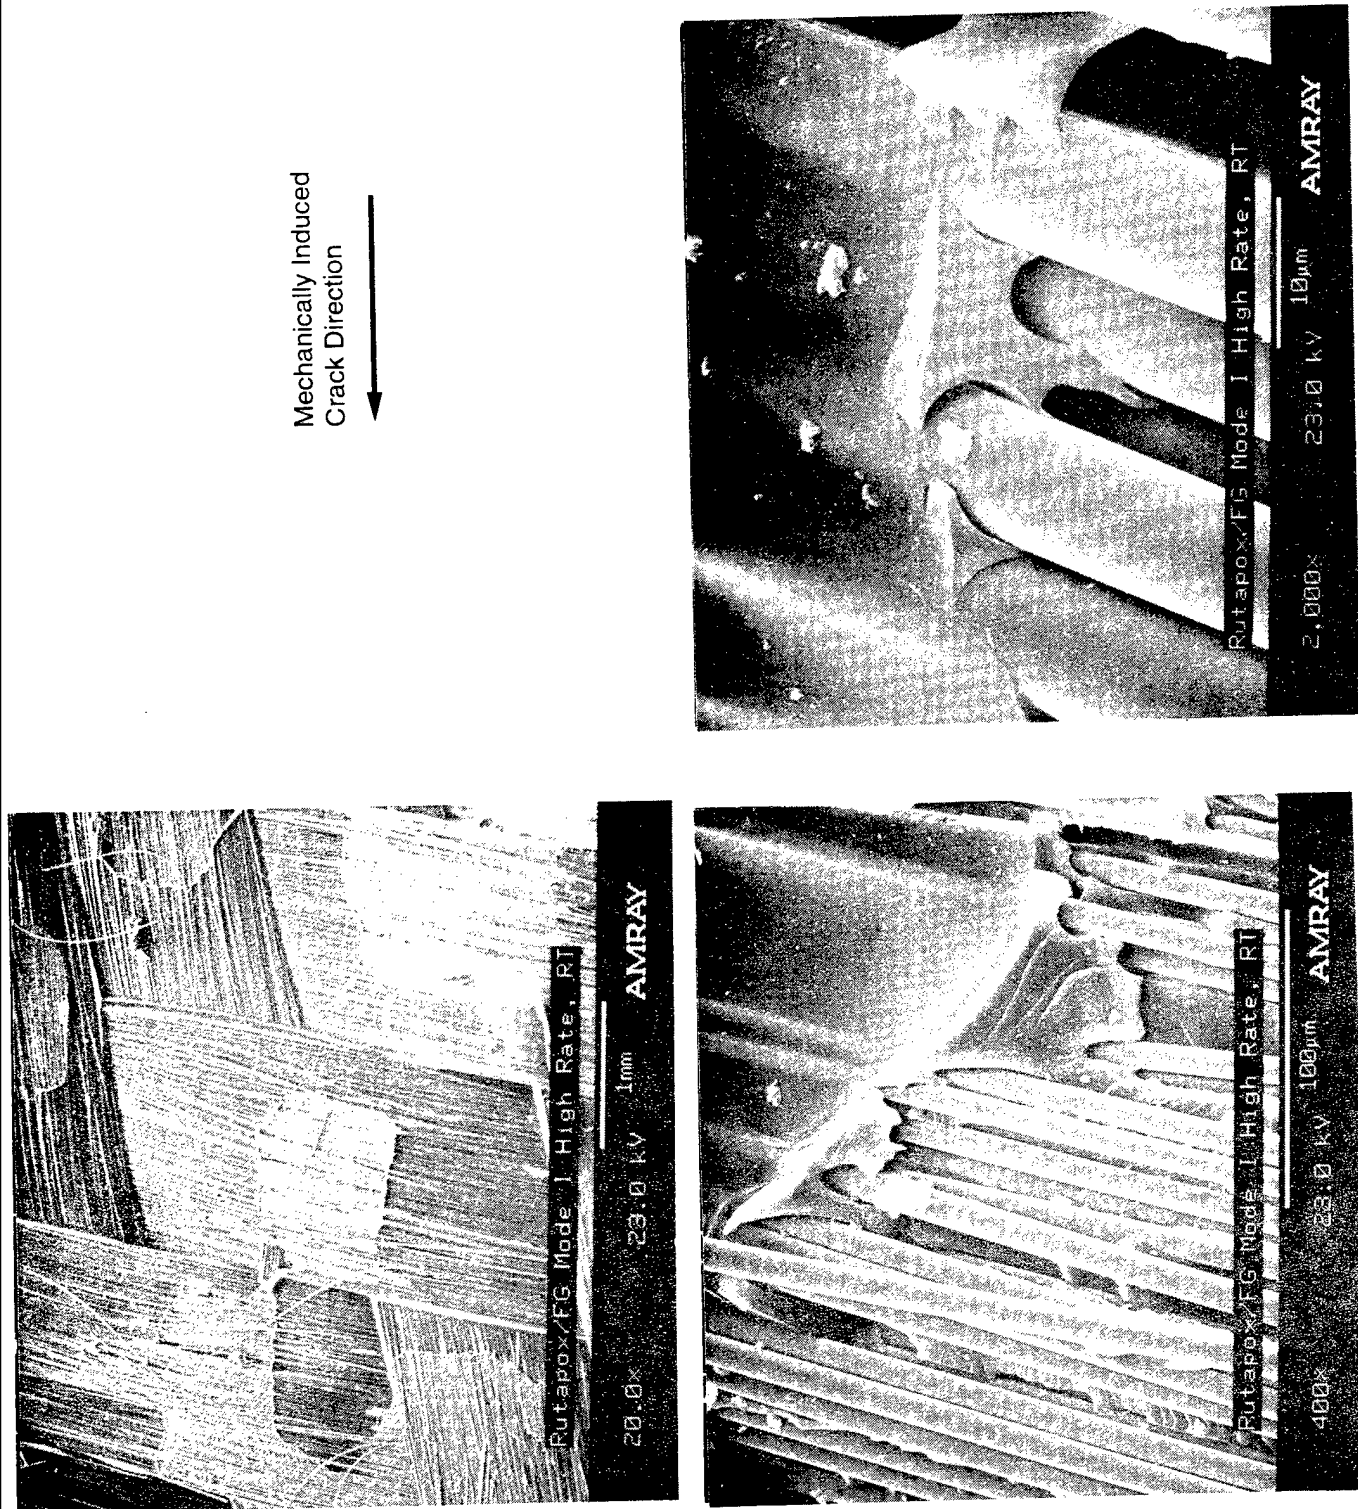
Figure 3.6-4. SEM Fractographs of a Rutapox/FG Fabric Interlaminar Mode I (Tensile) High-Rate Fracture Surface, RT

The fracture surfaces of both specimens exhibited similar features (Figure 3.6-4 & 3.6-5). The fabric tows parallel to the crack propagation orientation contained the hackles typical of a shear loading. Whereas the tows perpendicular to the crack direction exhibited ribbons of resin tearing from the fibers. The torn ends were generally bent towards the crack propagation direction.

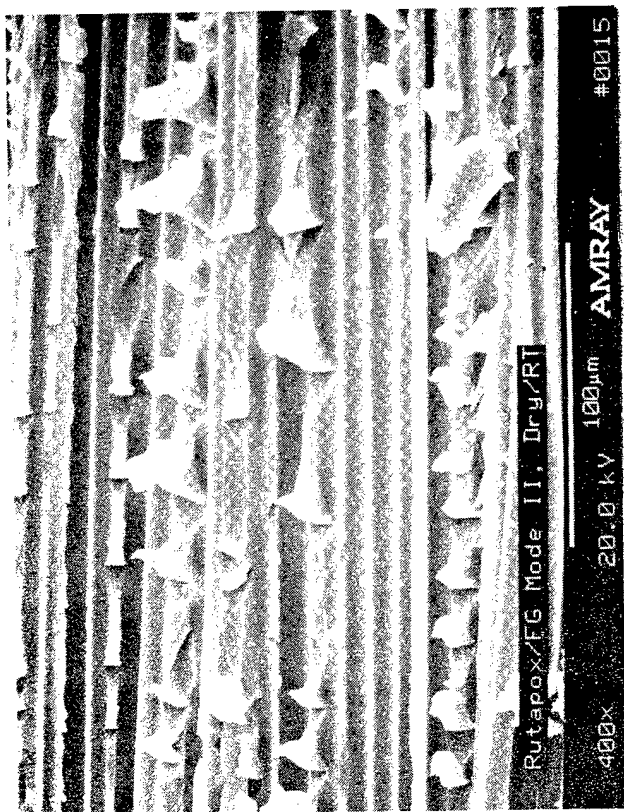
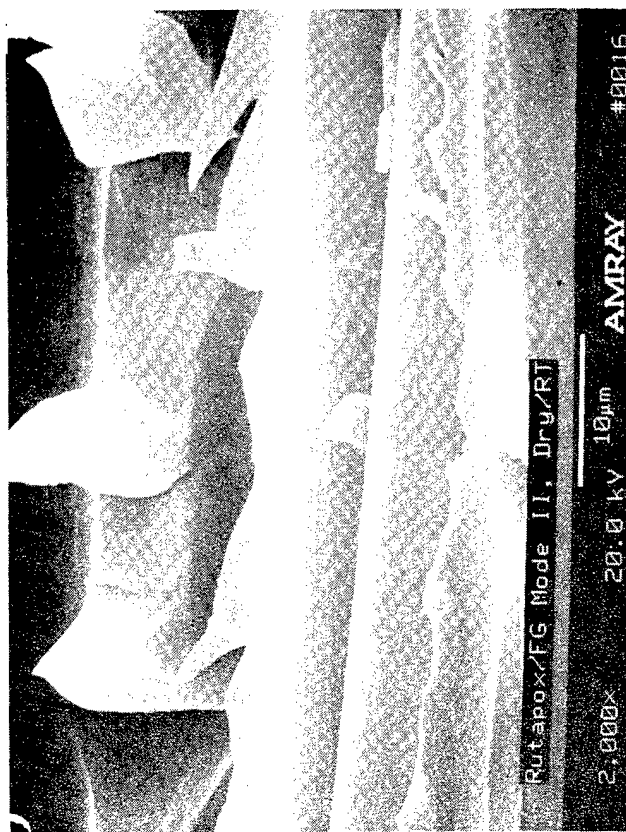
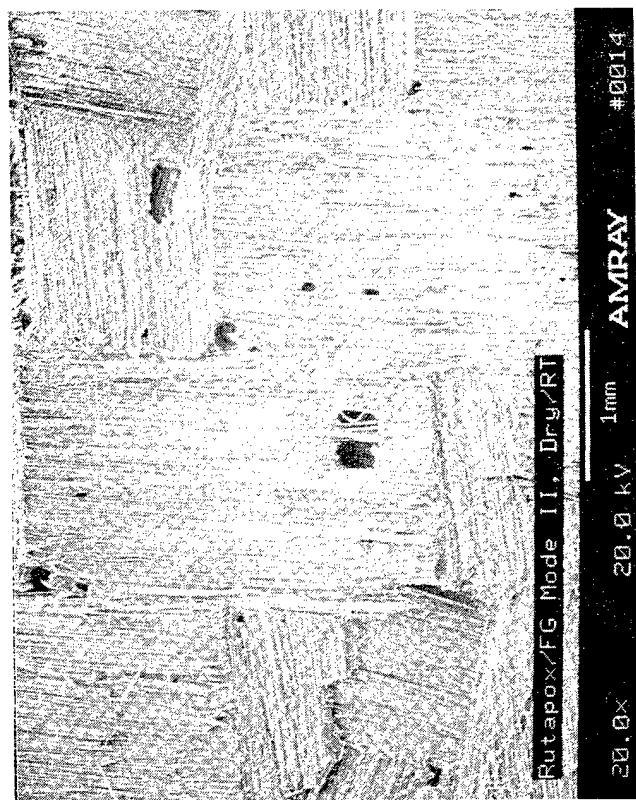
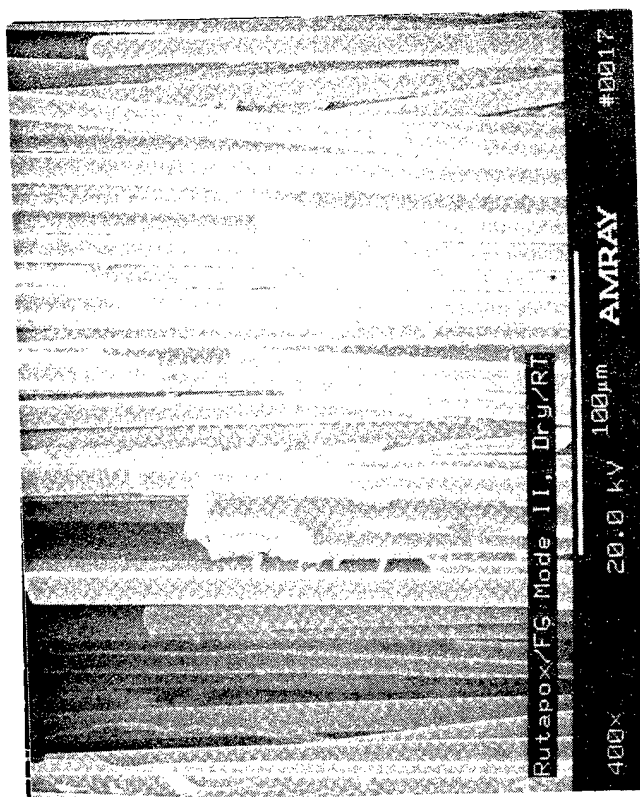
Figure 3.6-5. SEM Fractographs of a Rutapox/FG Fabric Interlaminar Mode II (Shear) Fracture Surface, RT

The fracture surface of the RT/Dry specimen was composed mainly of resin which indicates that the crack propagated through the interface between the fabric surface (as seen in the Hot/Wet fractographs) and the resin. In addition, voids were also present at the fabric tow intersections

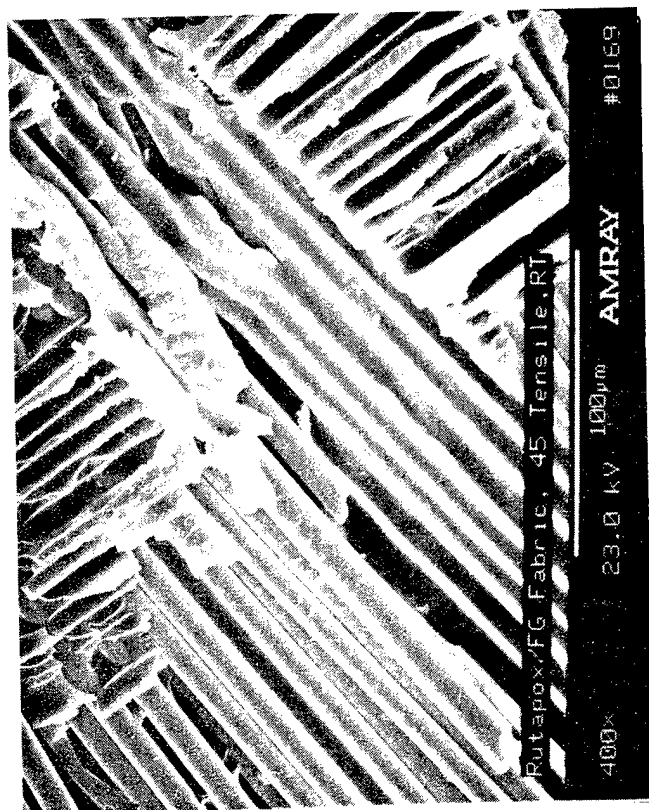
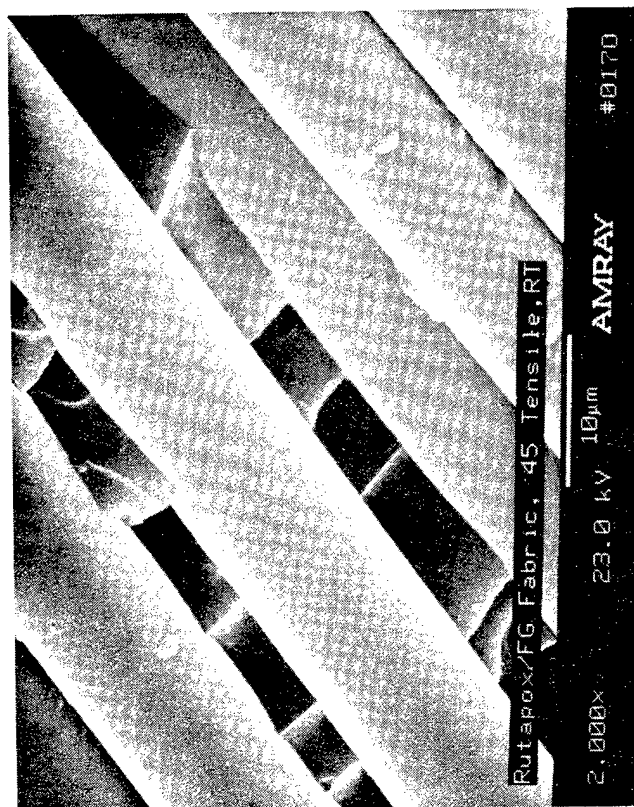
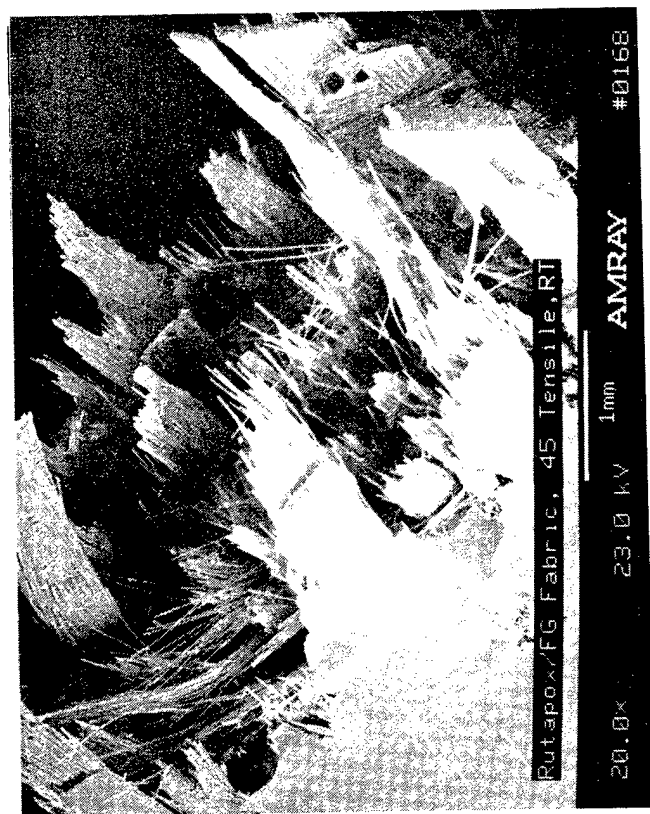
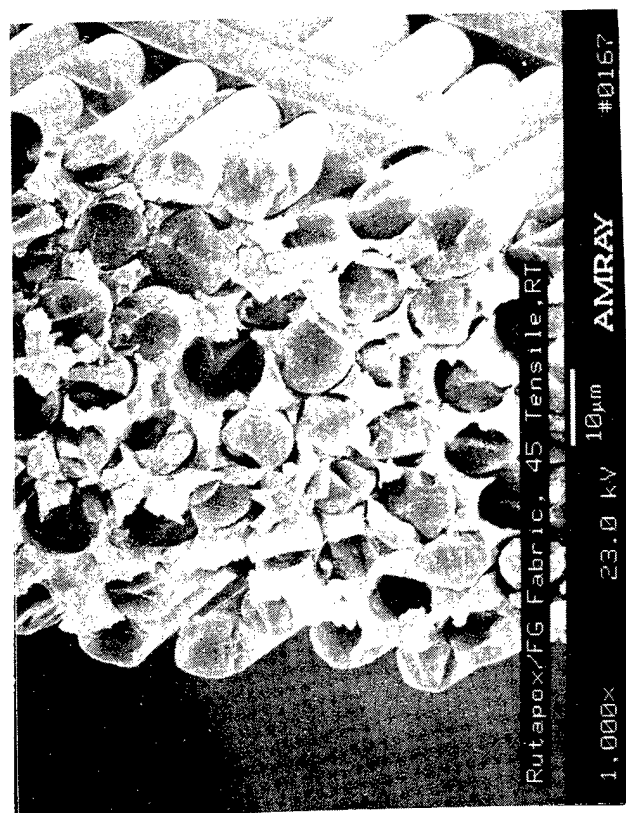
Figure 3.6-7. SEM Fractographs of a Rutapox/FG Fabric \pm 45° Tensile Fracture Surface, RT

The fabric specimen fracture surfaces (Figure 3.6-7) were more consolidated as compared to the roving specimen surfaces. There were fewer fiber pullout regions but wetting of the fibers did not appear to be as thorough. Furthermore, unlike the roving specimen, the fabric fiber ends exhibited a fracture morphology indicative of a compression loading. These were also grouped in more bundles compared to the roving specimen fiber ends.

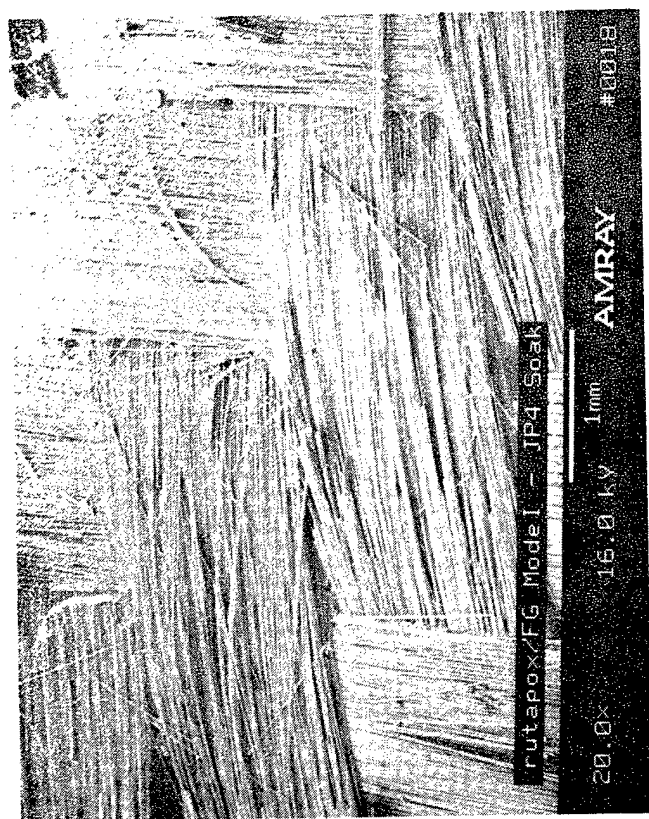
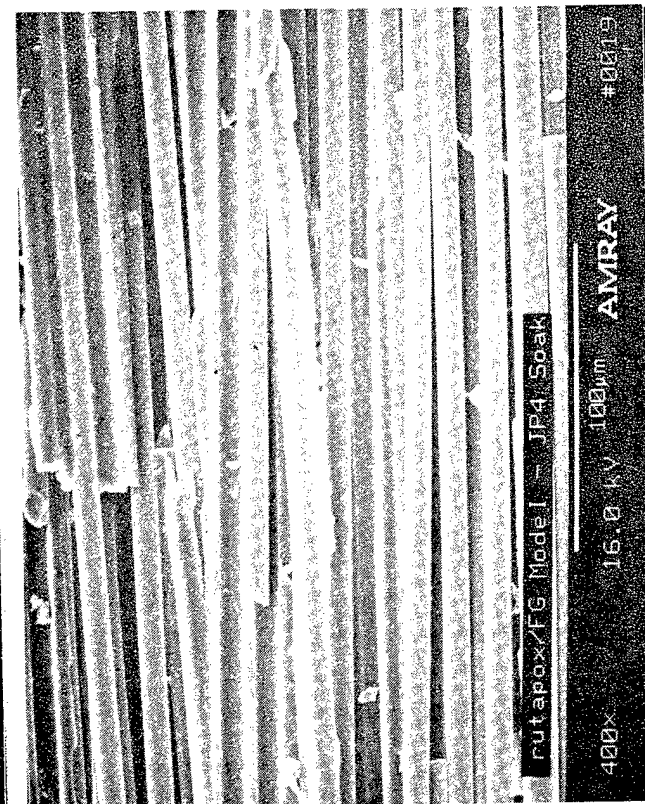
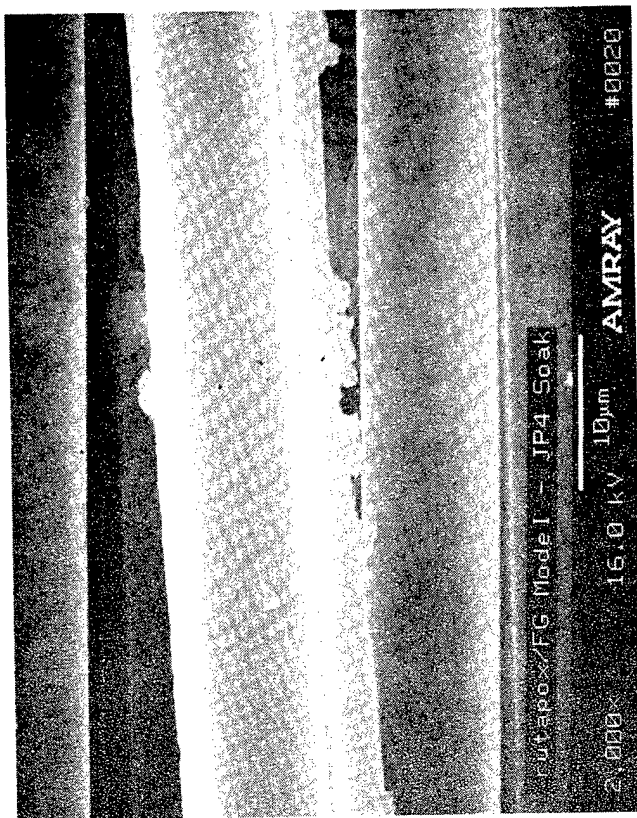
Figure 3.6-13. SEM Fractographs of a Rutapox/FG Fabric Interlaminar Mode I (Tensile) Fracture Surface Exposed to JP4 Jet Fuel for 7 days

For the Rutapox epoxy resin system, only four specimens were examined that were of the most severe environments; JP4, Acetone, MEK, and Hydraulic Fluid (Figure 3.6-14 through 3.6-16). Examination of the fracture surfaces revealed no degradation of the fracture features regardless of the exposure conditions.

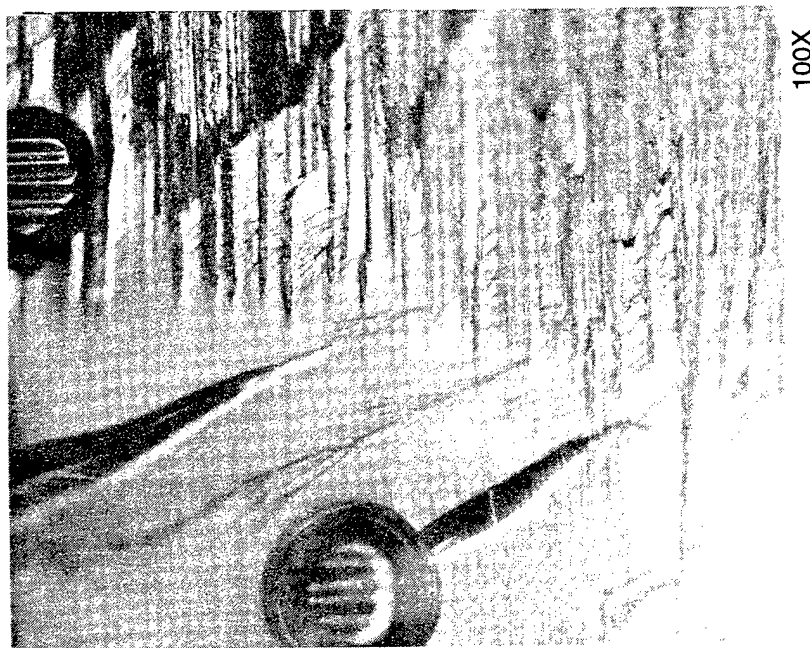
Figure 3.7-1. Optical Fractographs of a Rutapox/Graphite Fabric Interlaminar Mode I (Tensile) Fracture Surface, RT

The fracture surface (Figure 3.7-1 & 3.7-2) contained numerous resin-rich regions with voids distributed throughout the surface. These voids were likely the result of panel processing rather than a specific material attribute. This resulted in an overall shiny appearance when examined visually. SEM examination (Figure 3.7-1) revealed numerous rivermarks in the resin-rich regions indicating the crack growth direction. The resin between the fibers perpendicular to the fracture direction was composed of hackles with no specific discernible fracture direction.

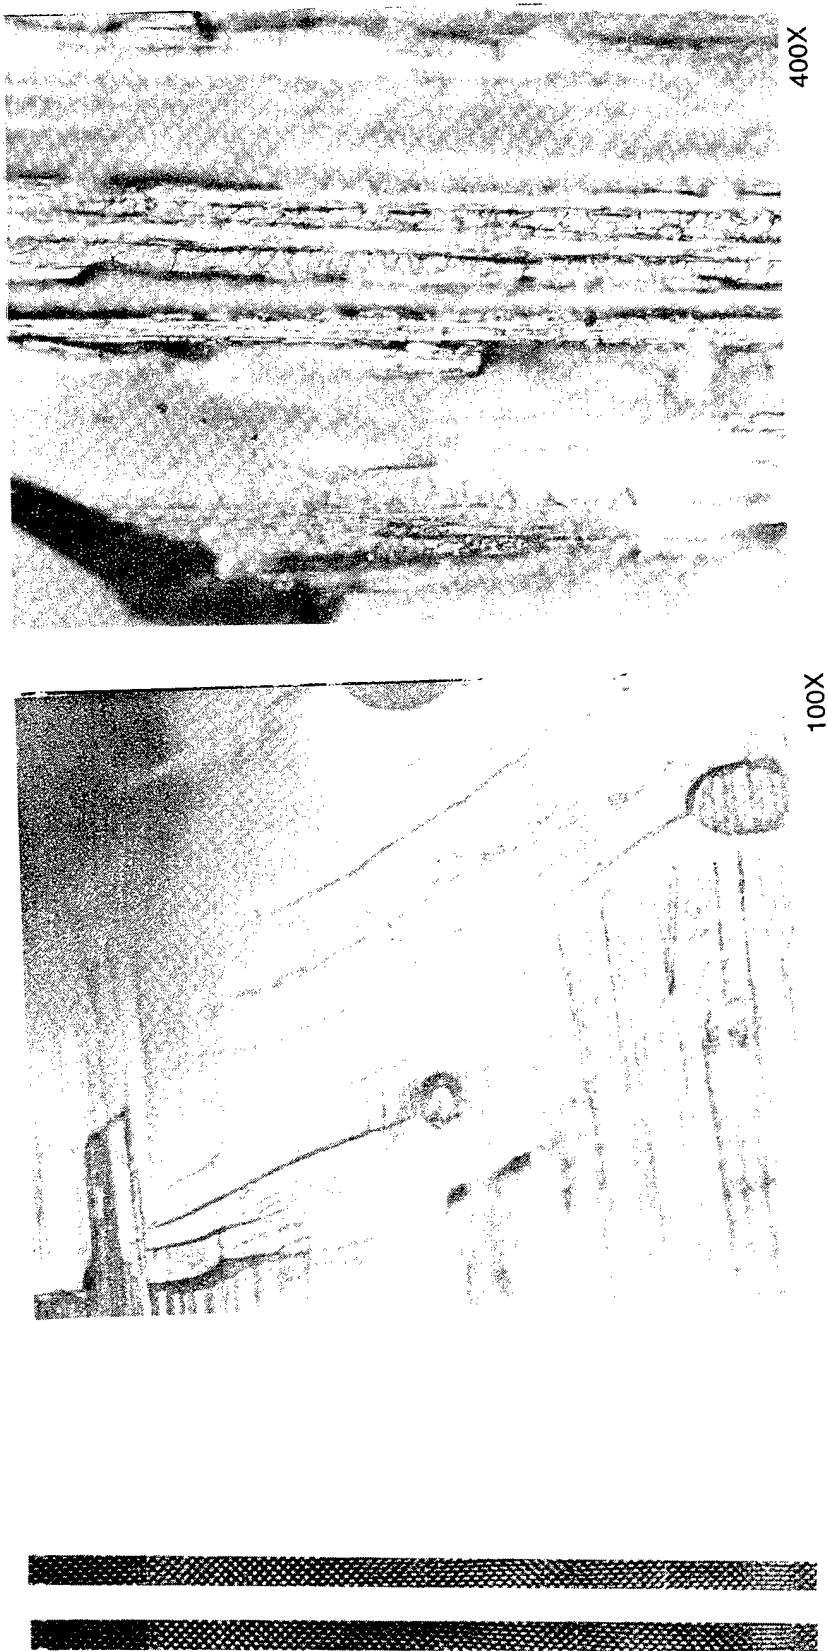
Figure 3.7-3. Optical Fractographs of a Rutapox/Graphite Fabric Interlaminar Mode I (Tensile) High-Rate Fracture Surface, RT

The high strain rate specimen fracture surfaces (Figure 3.7-3 & 3.7-4) were similar to the normal rate specimens, but the river patterns were more evident.

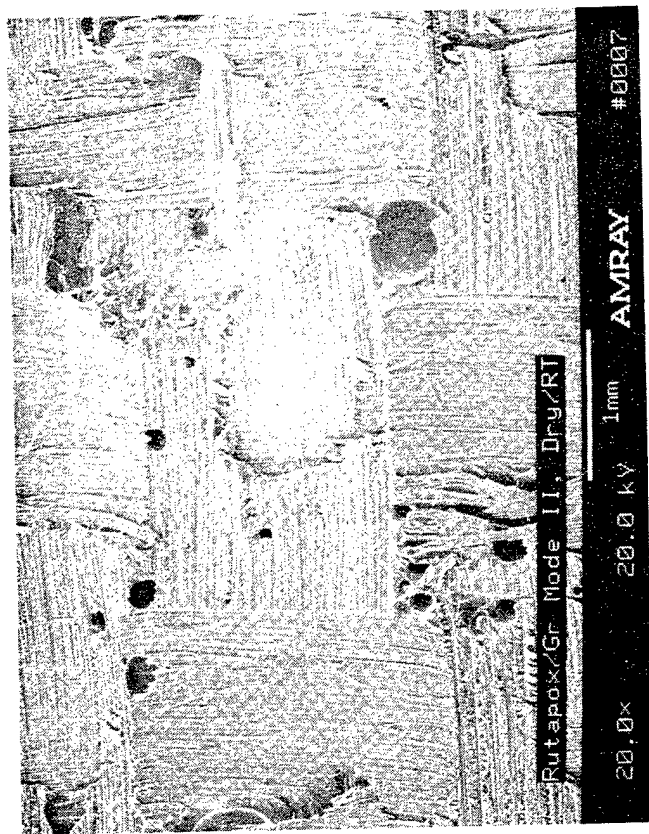
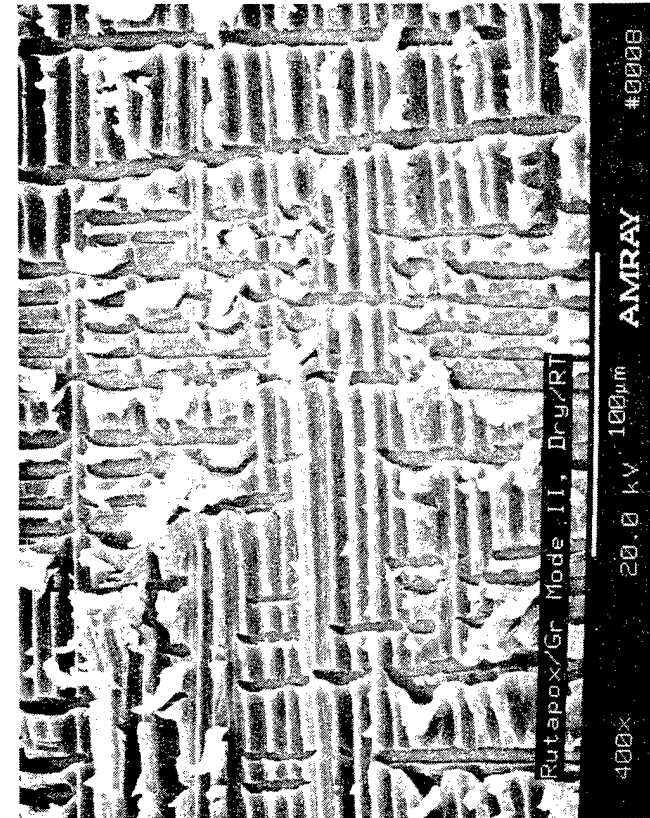
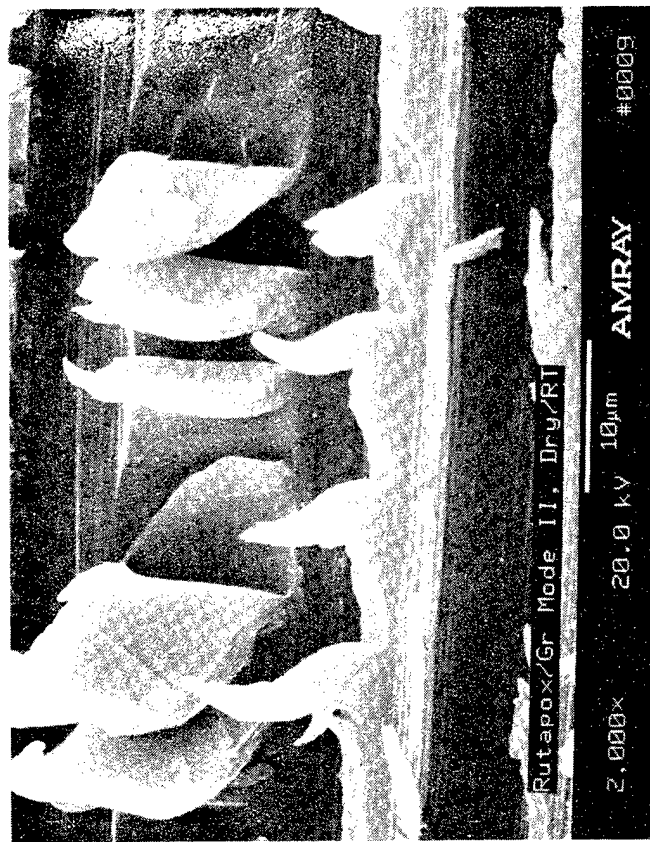
Figure 3.7-5. SEM Fractographs of a Rutapox/Graphite Fabric Interlaminar Mode II (Shear) Fracture Surface, RT

The visual appearance was generally rough similar to the mode I surfaces but with fewer shiny regions (Figure 3.7-5 & 3.7-6). The fracture surfaces were similar to the fiberglass specimens with the exception of the carbon fiber features as mentioned above. The fabric tows parallel to the crack propagation orientation contained the hackles typical of a shear loading and the tows perpendicular to the crack direction exhibited the ribbons of resin. The torn ends of the resin were generally bent towards the crack propagation direction.

The fracture surface of the RT/dry specimen was composed mainly of resin which indicates that the crack propagated through the interface between the fabric surface (as seen in the Hot/Wet fractographs) and

the resin. This resin fracture surface also contained translaminar cracks, perpendicular to the fibers, which are typical of shear cracked resin surfaces. In addition, voids were also present at the fabric tow intersections.
